MIRANDA HOUSE

ACCESS AUDIT REPORT

2024-2025

Prepared By :
EHS ALLIANCE

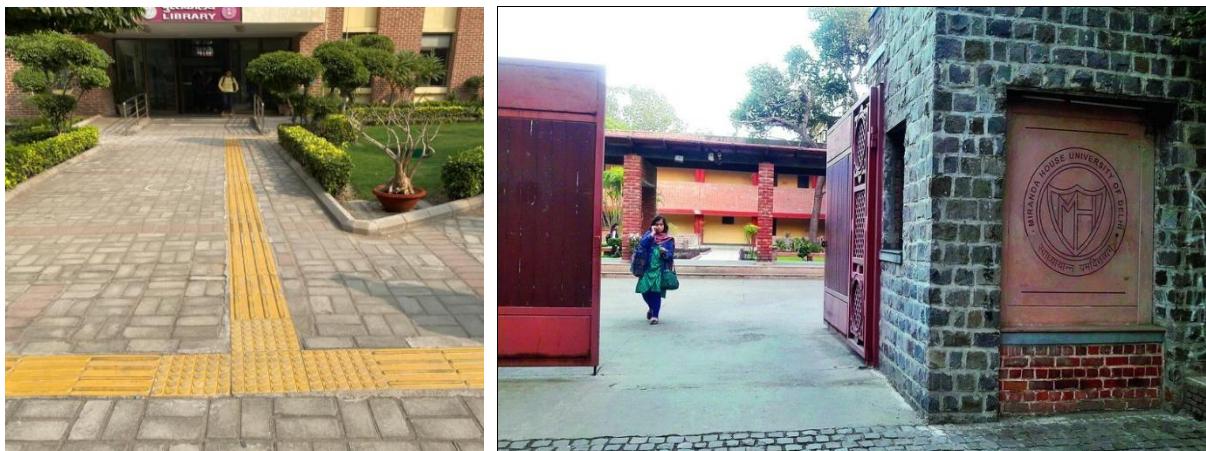
1.1 APPROACH AND MAIN ROAD

The building is easily accessible and is situated on a main road; nonetheless. Users who are blind are provided with tactile orientation.

- All of the entrance's surrounding area is levelled.
- Wheelchair users can easily approach the main entrance gate by using a curb ramp that levels the curb to the road.
- The current signage is both in Hindi and English.

Here, more signage that has better colour contrast can be placed to ensure that it is easily seen by everyone.

- Make sure the approach routes are periodically maintained.
- For wheelchair users to move freely, the road in front of the entrance gate must be barrier-free.
- In order to help all types of people, signage must be appropriate in every way.

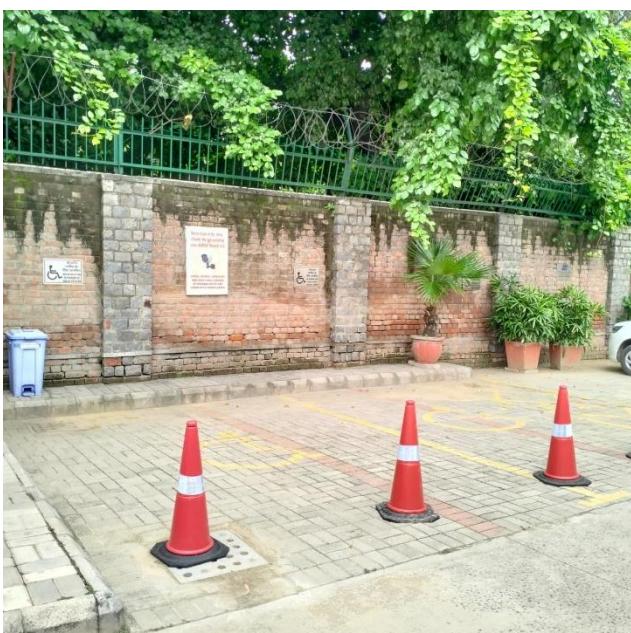
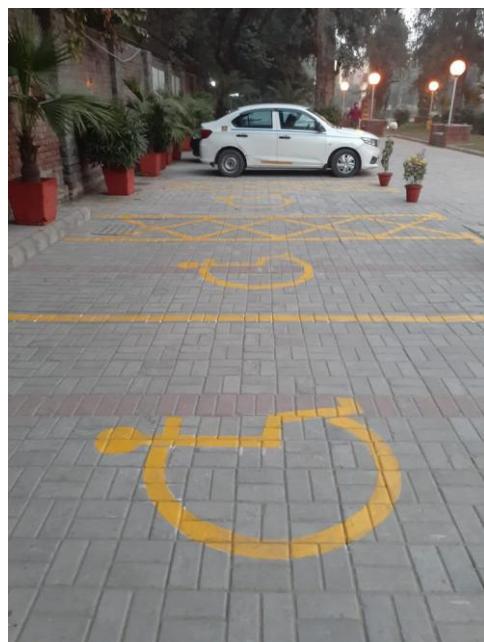
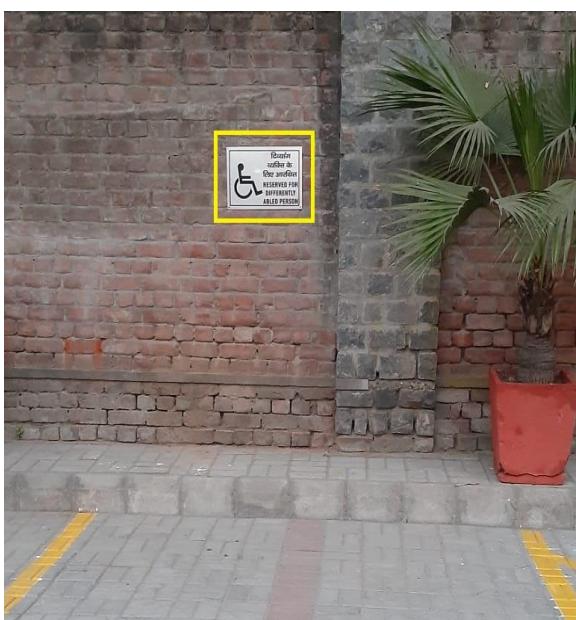
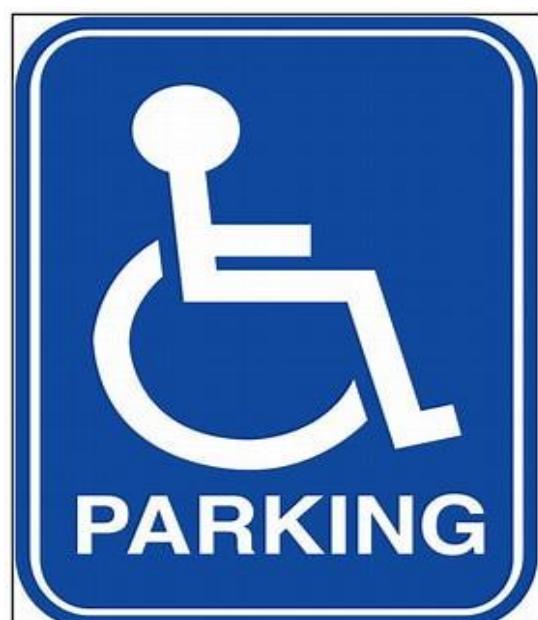
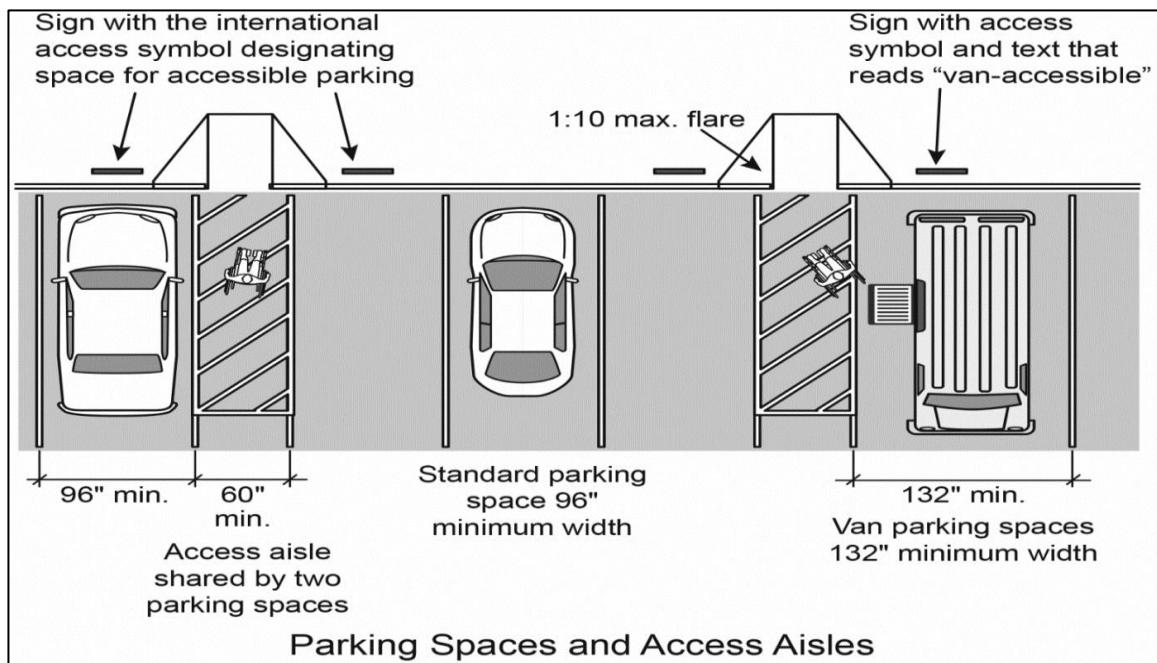
1.2 PARKING

- Within the building's grounds, there is a parking area designated for those with impairments.
- There is unmarked parking available for personnel and visitors in front of the administration department building, respectively.
- Signage states that 2 parking slots are available;
- Unorganized parking of cars and two-wheelers.

- Periodic painting or marking for parking space with clear visibility and navigation
- The provision of vehicle shelter is also necessary.

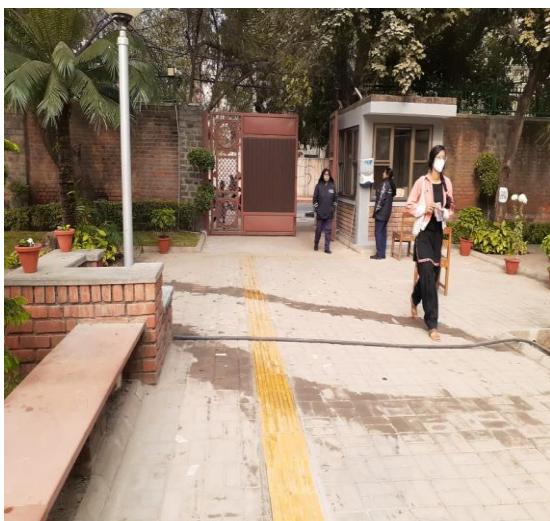
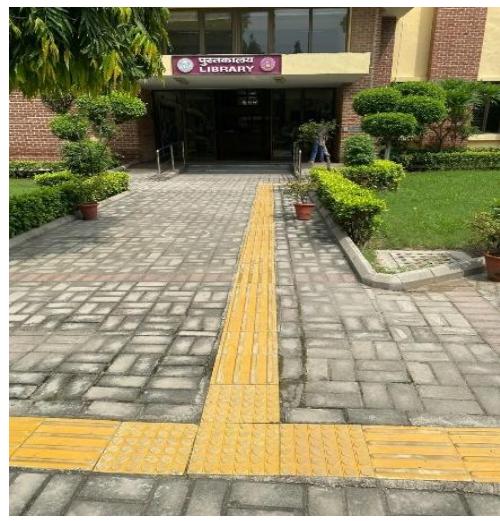
2.1 ENTRANCE

- The route to the entrance is accessible, and there are steps and a ramp for ingress.
- Three steps, a riser of 160mm, a tread of 300mm, and a width of 2550mm.
- Step nosing lacks colour contrast.
- A caution block and no railing.
- A fairly steep ramp is accessible at the gate, although it requires to have heat insulating layer at the handrail.

- Consider adding appropriate signage that reads "Accessible Route" to mark the entrance's accessible ramp.
- For visually challenged people, tactile warning blocks should be placed 400 mm before the start and finish of each ramp at the entrance to signal the level difference.
- Everywhere there are steps, there should be a 50mm color contrast on the tread edge to aid the elderly and persons with vision impairments even in low light.
- Handrails ought to be present on ramps and steps.

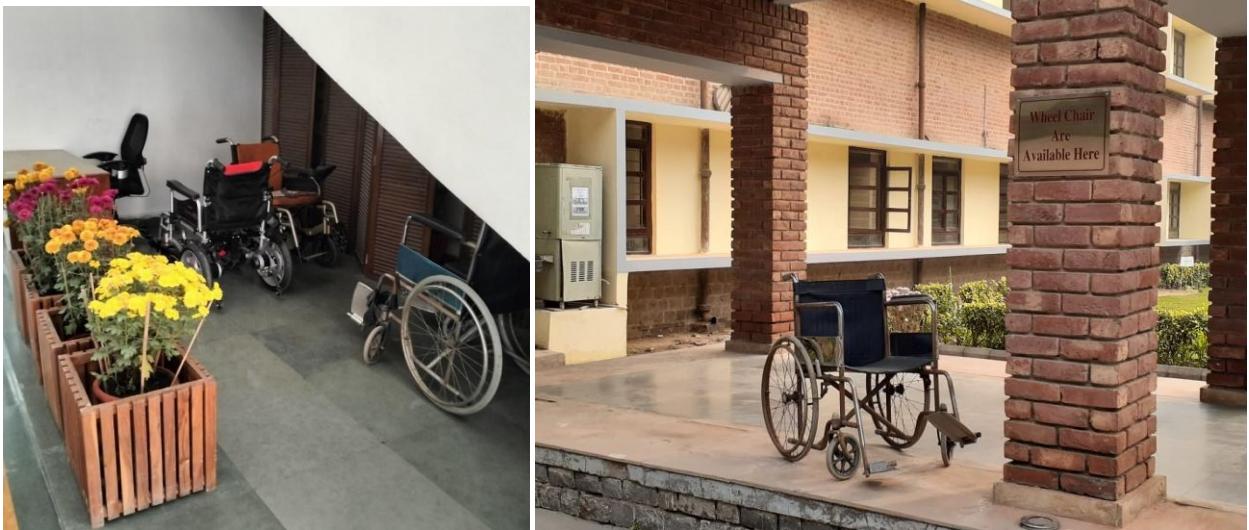
2.2 RECEPTION

- There was no specific reception desk signage visible.
- The enrolment procedures were carried out on-site at the college.
- There were no reception signs, and the reception area is 1100 mm tall.

- Provide guests with a distinct registration/reception desk at the entry, with a clear knee space of 350mm at the counter.

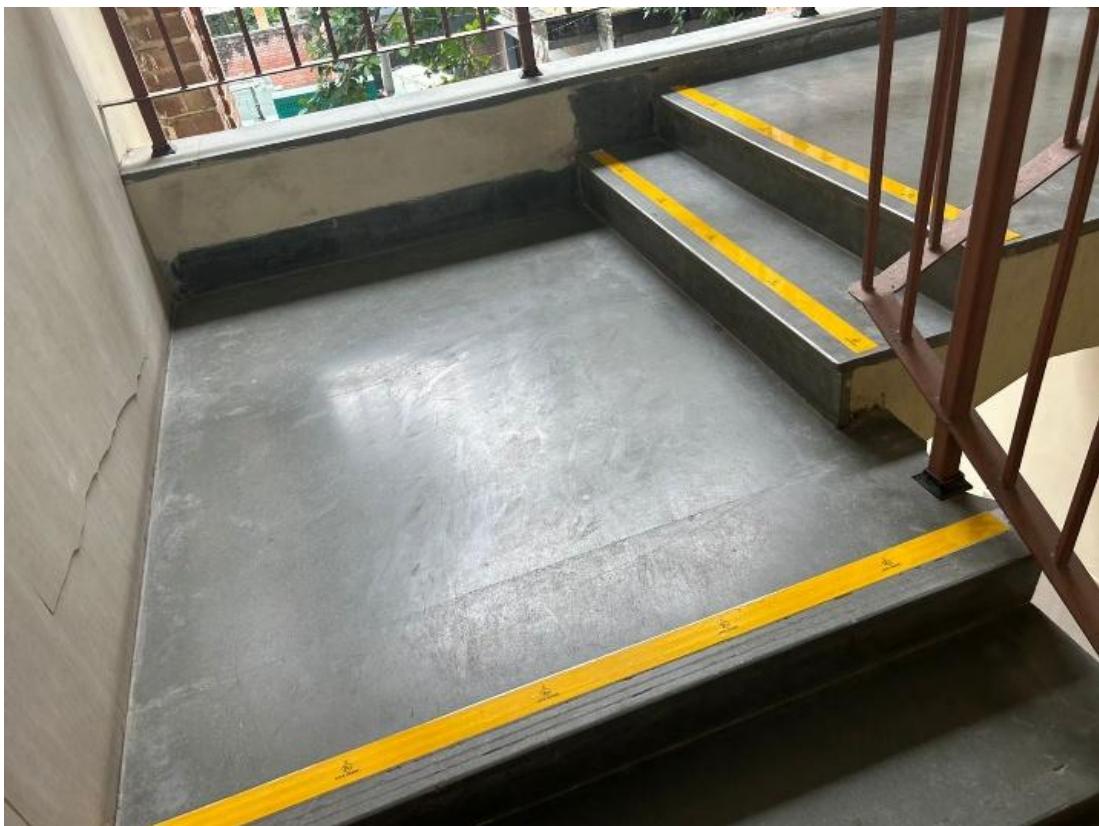
2.3 STAIRCASE

- There are 13 stairs with a landing, each with a riser of 160 mm and a tread of 260 mm that is 1450 mm wide.
- Wall-shaped handrails are present on both sides and extend up the stairs.
- The floor surface is non-slippery and non-reflective, which is a good practise.

- It is ideal to have railings on both sides and at two heights, or 700mm and 900mm, to accommodate adults and children of all sizes.
- Railing in open areas must be insulated for temperature (Hot/ Cold) effects.
- On the landing, the railings ought to remain in place.

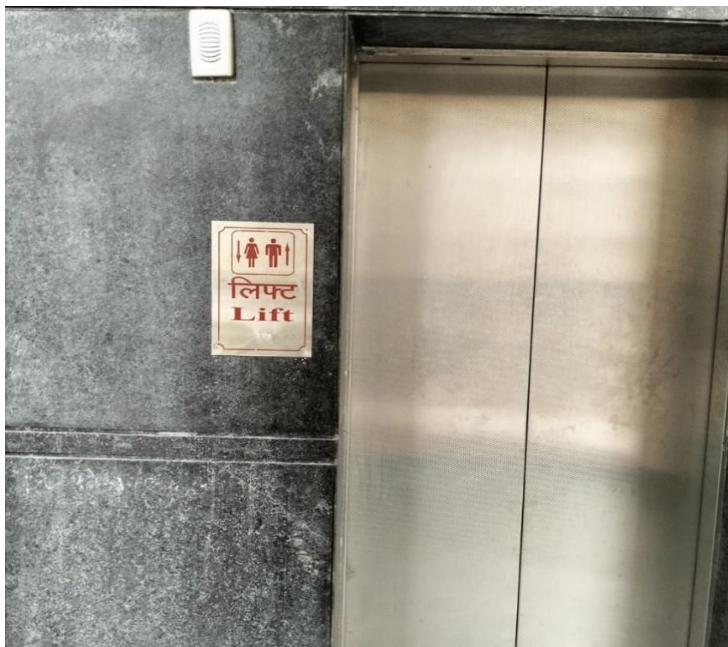
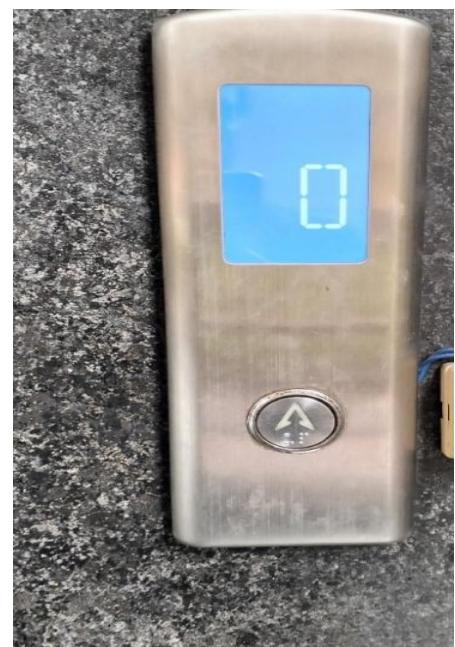
2.4 LIFT/ Elevator

- There is a lift in new building block that is open for faculty members and needy students.
- Buttons in the lift are with braille marking standards considering visually impaired people.
- The lift has audio announcement features in Hindi and English (dual language).
- The lift has help and call functions for any kind of assistance.
- The lift has a proper lighting system installed for better visibility.
- Rear view mirror is already placed inside the lift for better visibility and convenience.
- For a wheelchair user to independently utilize the lift there is sticker pasted in front of lift.
- QR code stickers are available on every class rooms and important places.

- At each entry, there needs to be clear signage pointing in the direction of the elevator.

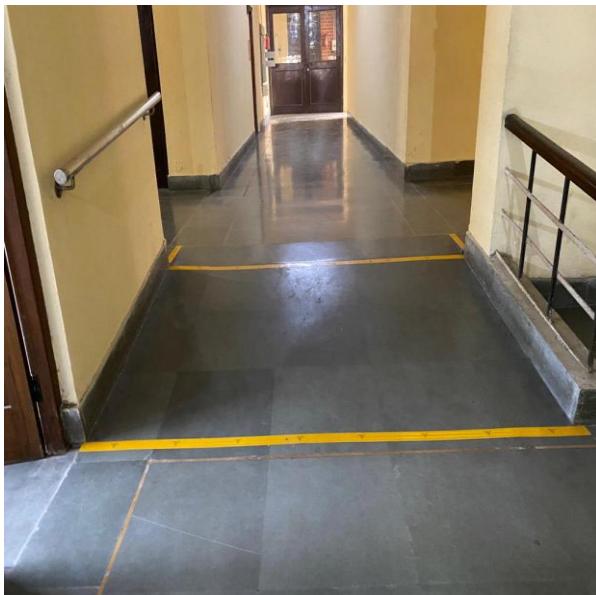
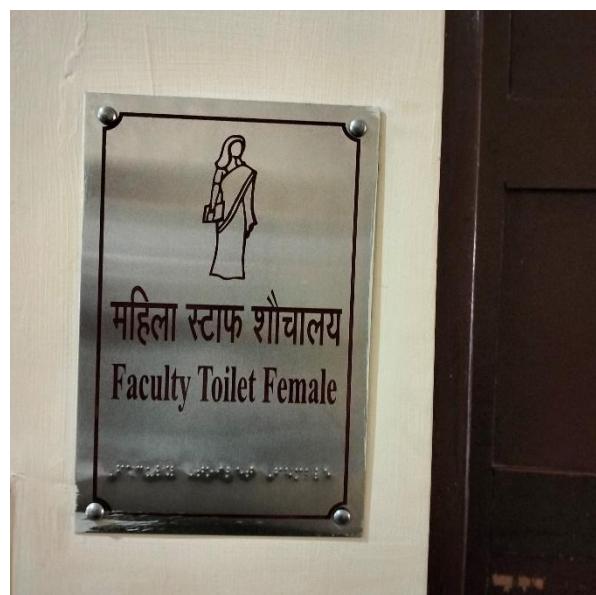
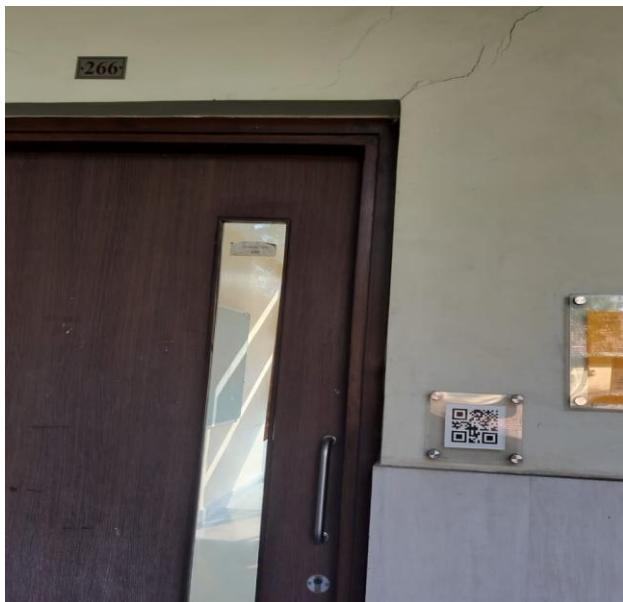
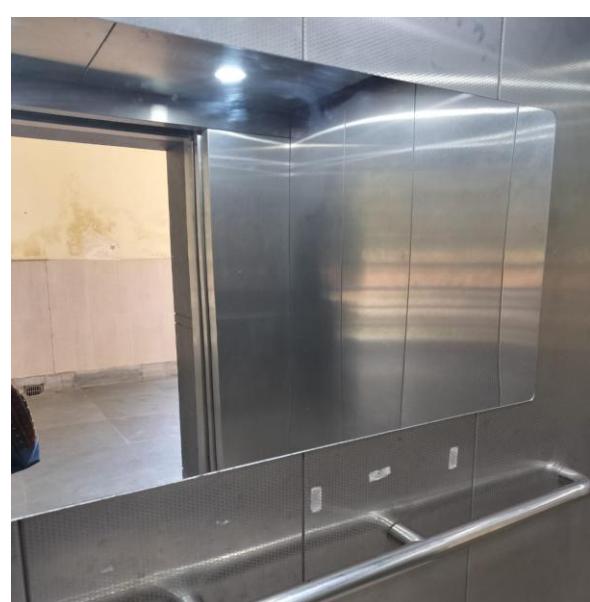
2.5 CORRIDORS AND DOORS

- The hallways are sufficiently wide (2300 mm), and no protruding objects lie in between.
- Displaying vibrant colour contrast.
- The illumination is just ok, in future, please maintain minimum 200 Lumens in corridors.
- Although slightly brilliant and reflective, the surface is not slippery.
- There is appropriate signage at the entrance.
- The signage that is currently displayed is too high and has poor color contrast.

- Doors with a handle height of 1200mm and a clear width of 1300mm.
- Consider adding adequate, evenly distributed illumination to the hallways.
- Give the entrance, walls, ceiling, and floor contrast in colour in future maintenance work.

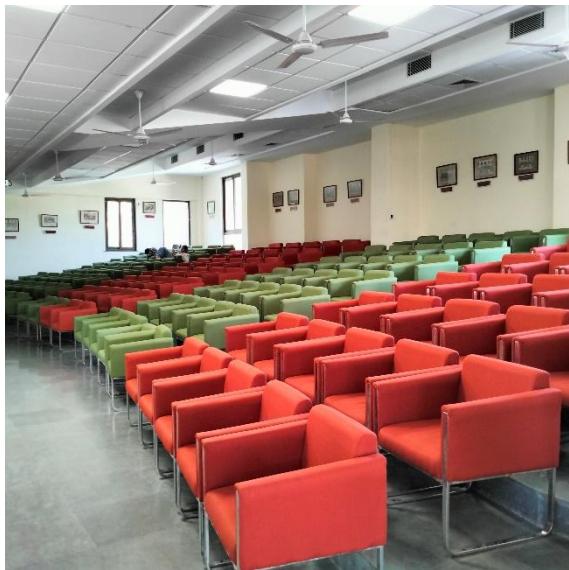
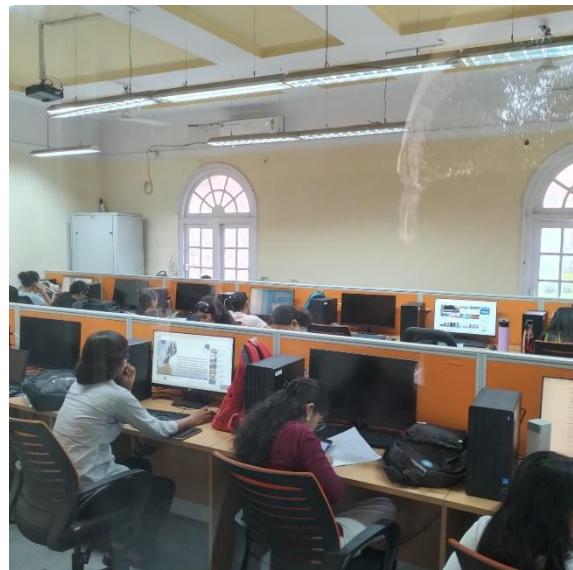
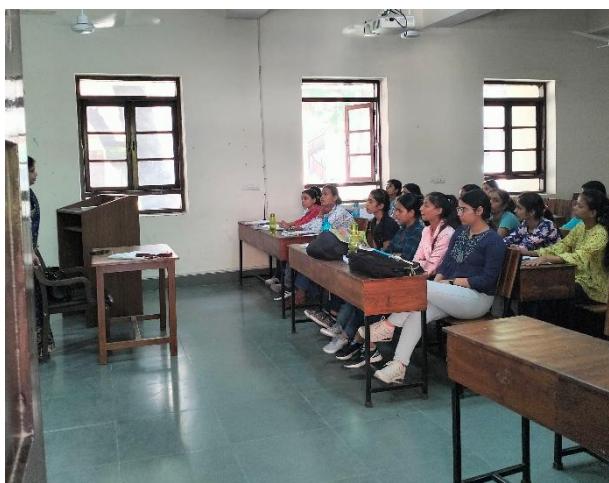
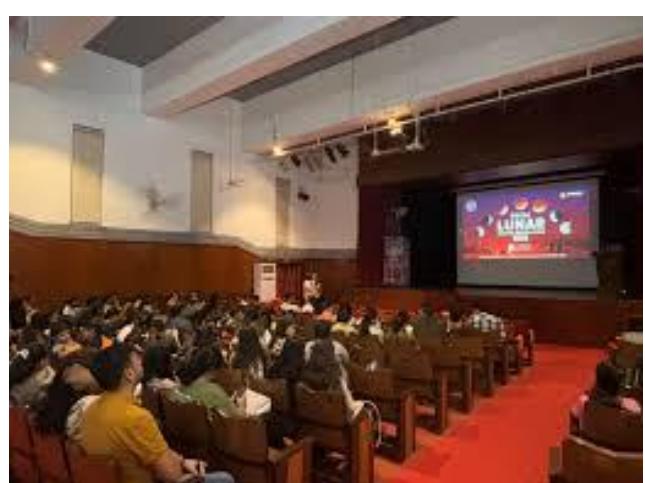
2.6 AUDITORIUM/ CLASSROOM

- The auditorium is located on the ground floor of the structure.
- Riser: 150mm, tread: 280mm, width: 900mm, inaccessible to people with disabilities
- Doors are 920mm wide.
- Classrooms and other important places have QR code scanner for more informations.

- Stripes of different colours should be present on the steps.
- The steps shouldn't be as reflective as they currently are.
- A suitable ramp should lead to the stage or allocate a few seats (considering the admission count) for VI people in the front row on any side.

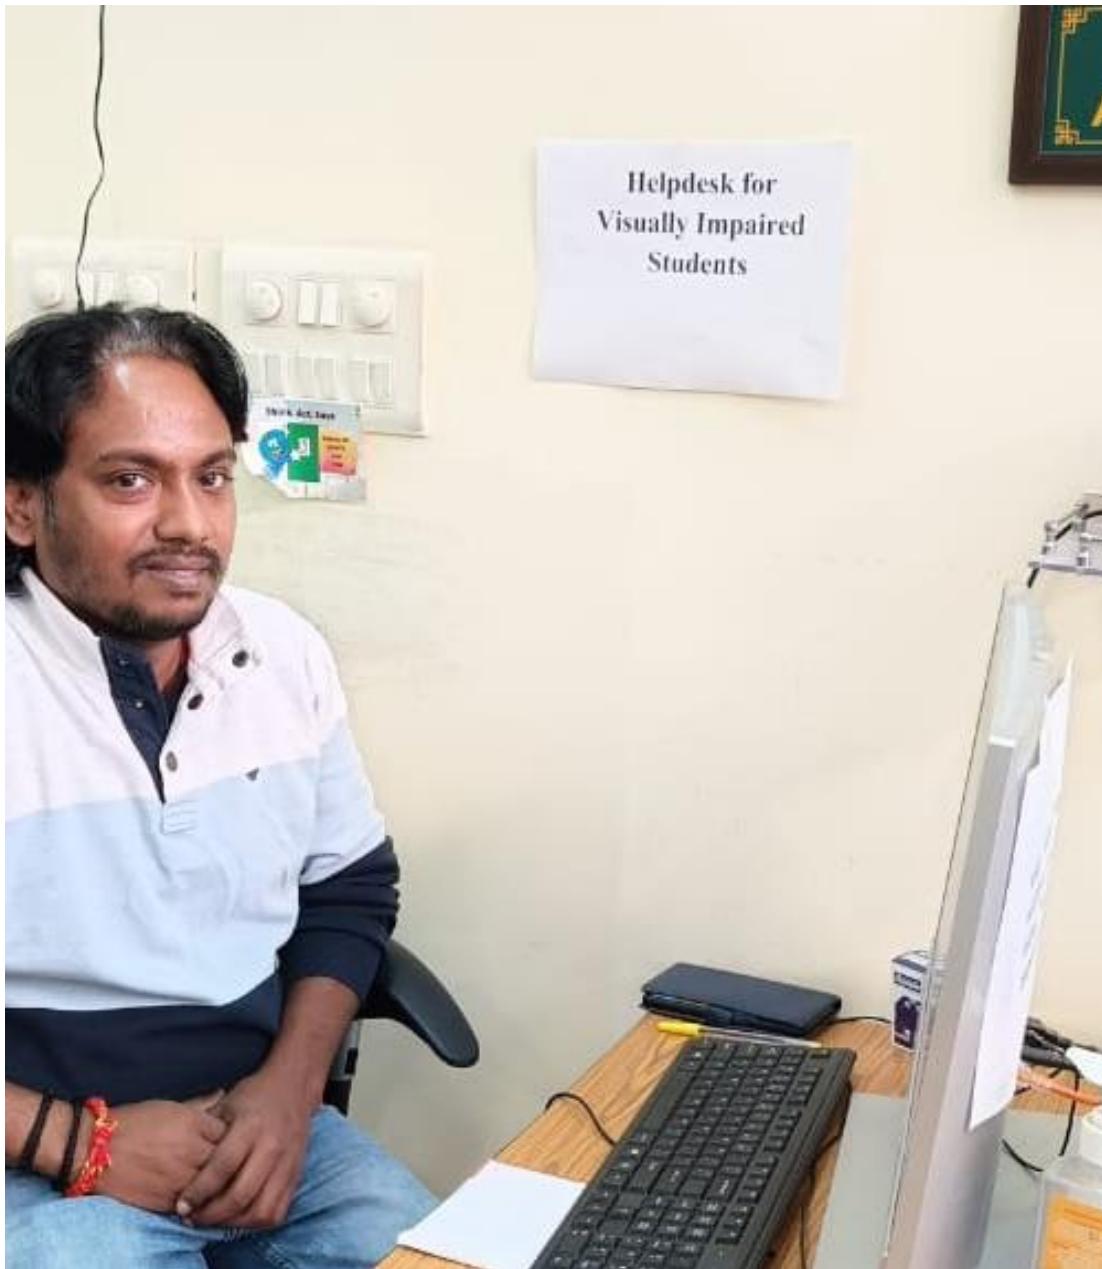
2.7 LIBRARY – HELP CENTER

- Library space is offered in the same building.
- There are two ramps for entry.
- Library building is easy to reach but not that easy to access by visually impaired person, so library staff assisting in person to needy students as per the requirements.

- Ramps to enter into the library, needs to be marked with proper color contrast.
- Regular maintenance of ramps and handrails is suggested by the audit team.
- Signage needs to be visible at a clear height and color contrasted.

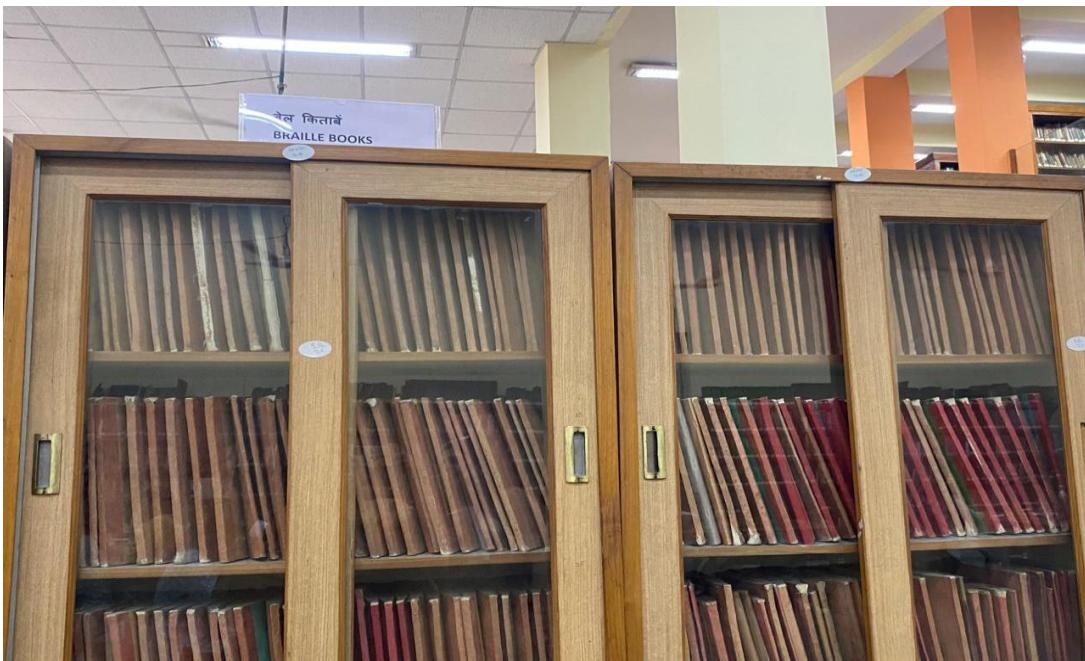
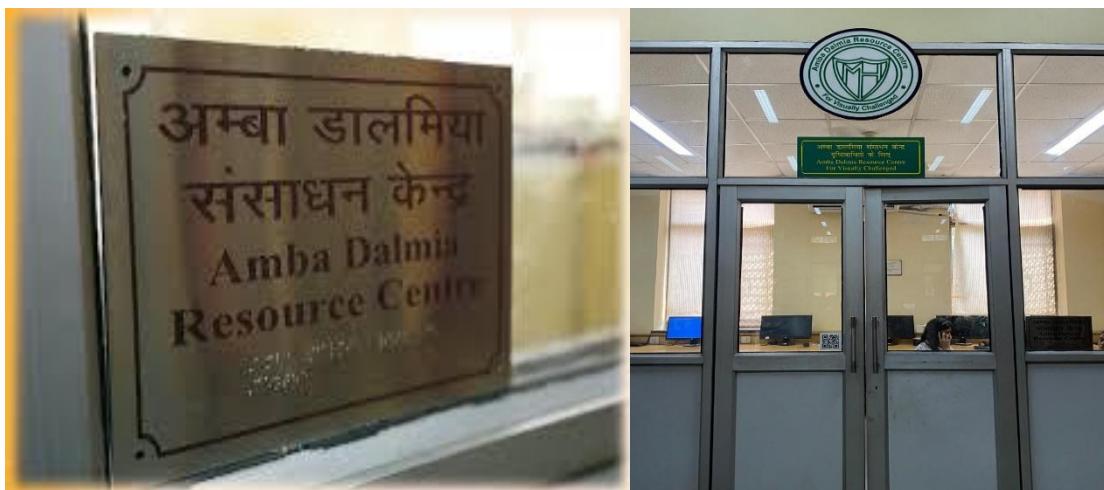
2.8 Amba Dalmia Resource Centre for Visually Challenged

- Amba Dalmia Resource Centre is located in library area.
- There are two ramps for entry.
- Library building is connected with tactile path that is in very good condition and maintained
- Library building is easy to reach but not that easy to access by visually impaired person, so Library staff assisting in person to needy students as per the requirements.
- Miranda House has expanded its existing Amba Dalmia Digital Resource Centre (ADRC) . As part of this expansion, 25 state-of-the-art computers have been installed in the center. The aim of this center is to empower visually impaired (VI) girl students by imparting them skills focused on Education, Mobility and Employment Training (EMET). The expanded center will be known as 'Empowerment and Skill Development Centre, an Augmentation of ADRC'.

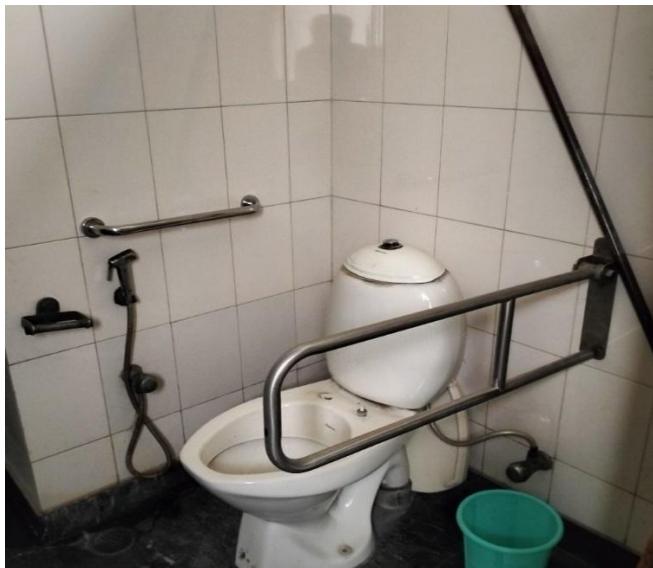
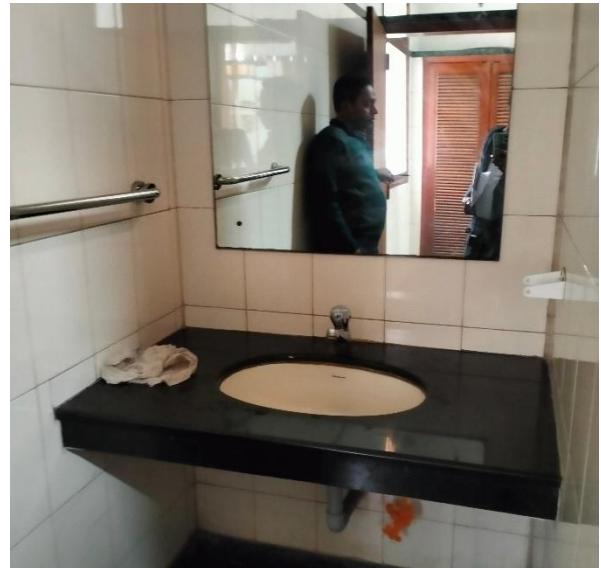
2.10 TOILETS

- The signage is illegible and insufficient.
- The urinal has a 700 mm urinal height and a stepped (100) entrance.
- A washbasin with a 1000mm height but no mirror.
- Western toilet with a 400mm height.
- There are inadequate sanitary conditions and proper toilet maintenance.
- The restroom lacks adequate illumination and colour contrast.

- Install sufficient directional signage pointing to an accessible public restroom.
- Ensure that the toilet unit is routinely maintained and cleaned.
- To prevent accidents due to slipping/ skidding, it is advisable to keep your toilet floor dry.
- Adequate Lighting Without Glare.
- Emergency Assistance Feature.
- Lever-type Fittings.

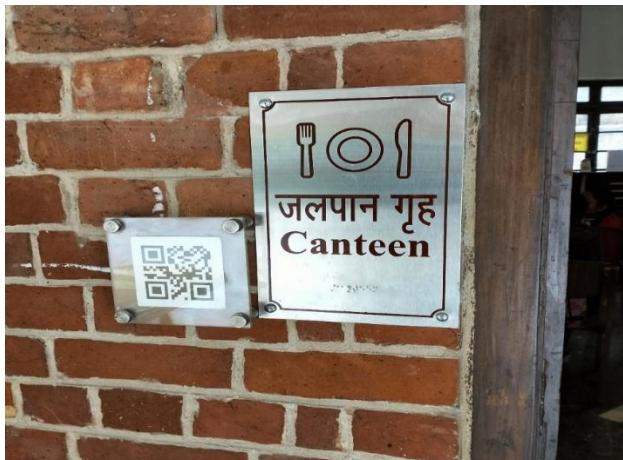
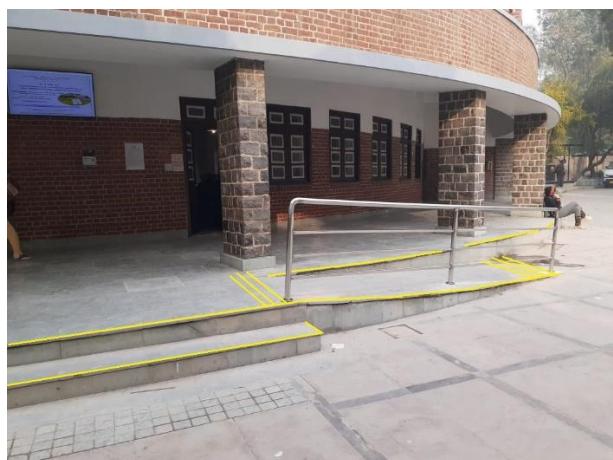
2.12 CAFETERIA

- The college had a main canteen and a few tuck shops on the college premises.
- Both a ramp and steps are used for entry and the main gate has signage with braille.
- The corridor is approximately 3000 mm wide.
- Water is only available at tables and is available at a height of 800mm.

- The access to the canteen shouldn't have any obstacles.
- There should be a wide enough gate so that entering the canteen won't be difficult.
- Wheelchair users need a counter with enough room for their knees.
- Staff Sensitization and Training, Train canteen staff to assist VI users—for example, reading out menu options clearly, describing food items, and guiding them safely to seating areas.
- Consistent Layout
- Audio Guidance or Announcement System
- Non-Slip, Obstruction-Free Flooring, ensure that the floor is even, non-slippery, and clutter-free to prevent tripping hazards. Avoid movable stands or bins in walking paths.
- Accessible Seating Arrangement, Keep at least a few barrier-free tables and chairs near the entrance or along tactile paths. Maintain enough circulation space for easy movement.

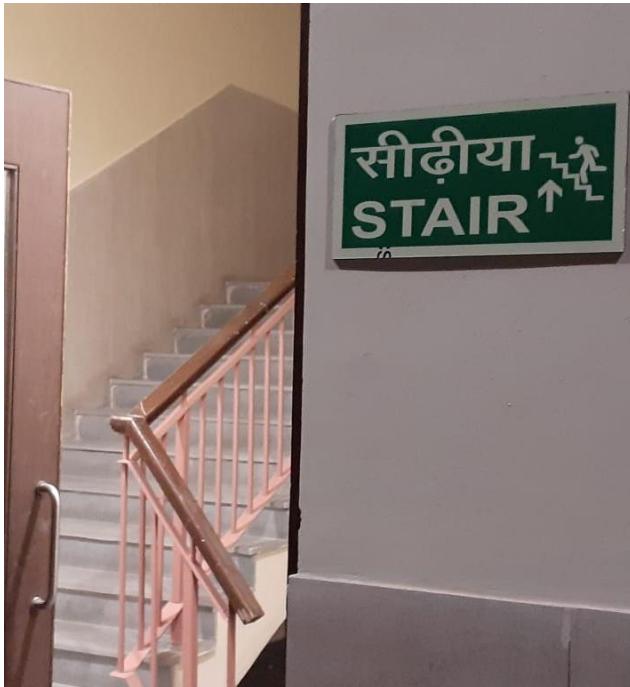
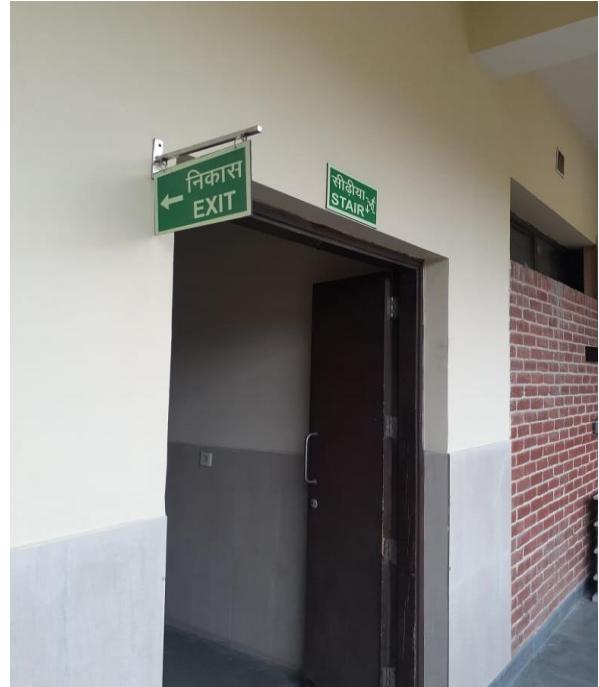
2.13 EMERGENCY EVACUATION

- There are many emergencies signage for any bodies.
- Few more signage are required according to the emergency evacuation plan.

- At key positions on each floor or level, emergency exits should have both auditory (hooter type) and visual (flashing bulb) alarms.
- Conduct recurring training sessions for personnel on handling emergencies and promoting disability equality.
