MIRANDA HOUSE

UNIVERSITY OF DELHI

ACCESS AUDIT REPORT

2023-2024

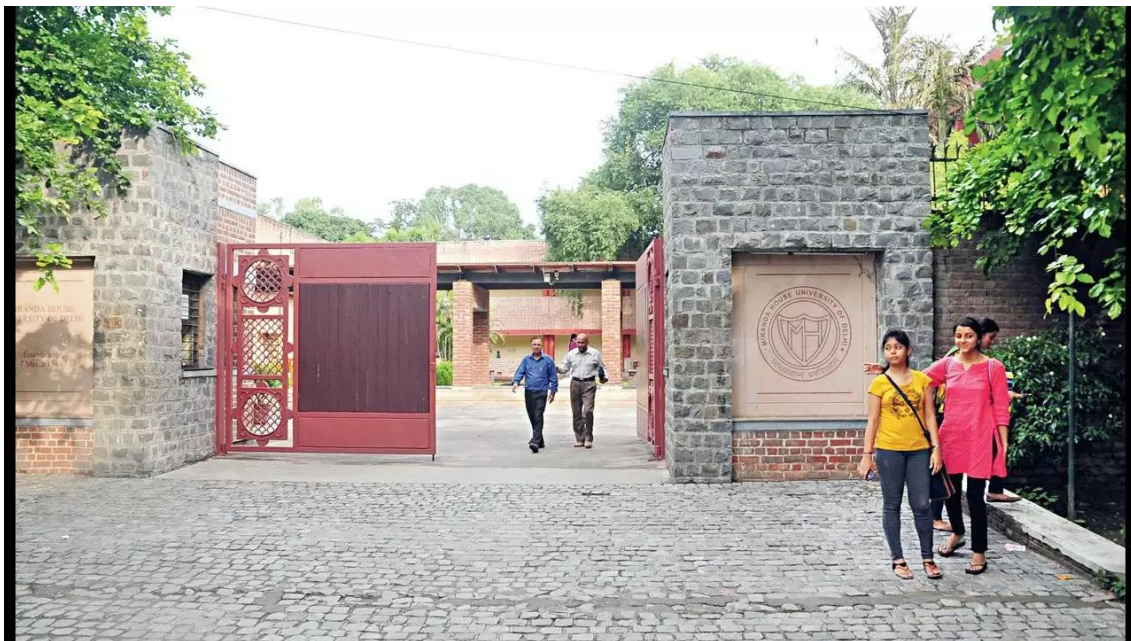
1.1 APPROACH AND MAIN ROAD

The building is easily accessible and is situated on a main road; nonetheless. Users who are blind are provided with tactile orientation.

- All of the entrance's surrounding area is levelled.
- Wheelchair users can easily approach the main entrance gate by using a curb ramp that levels the curb to the road.
- The current signage is both in Hindi and English.

Here, more signage that has better colour contrast can be placed to ensure that it is easily seen by everyone.

- Make sure the approach routes are periodically maintained.
- For wheelchair users to move freely, the road in front of the entrance gate must be barrier-free.
- In order to help all types of people, signage must be appropriate in every way.

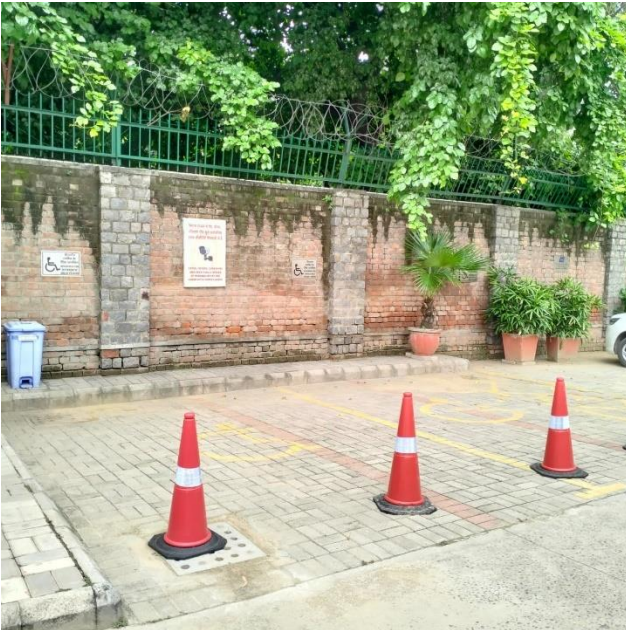
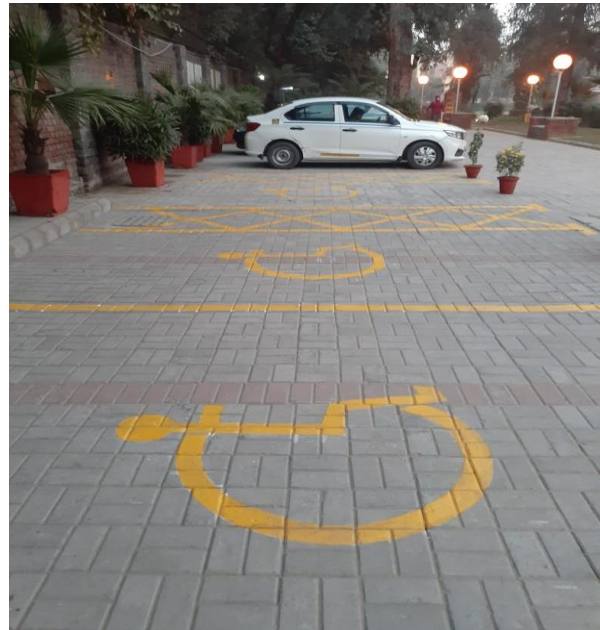
1.2 PARKING OBSERVATIONS

- Within the building's grounds, there is a parking area designated for those with impairments.
- There is unmarked parking available for personnel and visitors in front of the administration department building, respectively.
- Signage states that 2 parking slots are available;
- Unorganized parking of cars and two-wheelers.

- Periodic painting or marking for parking space with clear visibility and navigation
- The provision of vehicle shelter is also necessary.

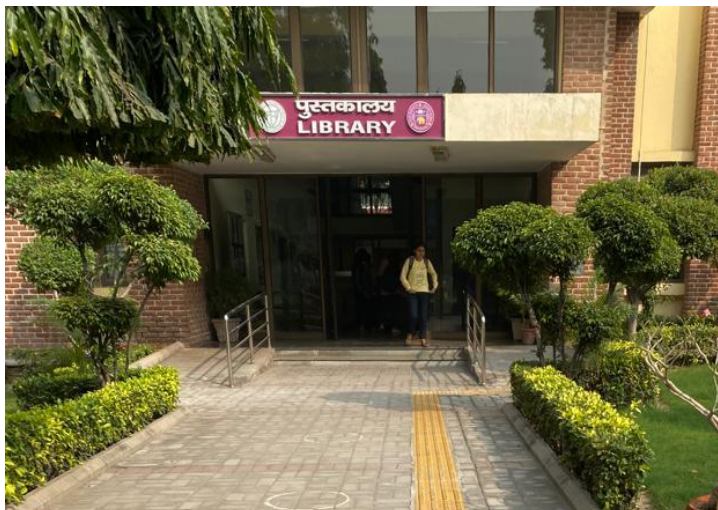
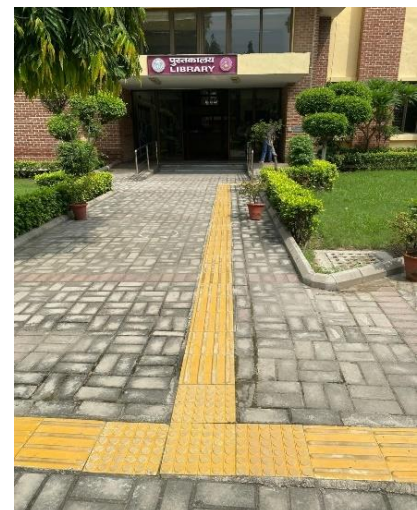
2.1 ENTRANCE

- The route to the entrance is accessible, and there are steps and a ramp for ingress.
- Three steps, a riser of 160mm, a tread of 300mm, and a width of 2550mm.
- Step nosing lacks colour contrast.
- A caution block and no railing.
- A fairly steep ramp is accessible at the gate, although it requires to have heat insulating layer at the handrail.

- Consider adding appropriate signage that reads "Accessible Route" to mark the entrance's accessible ramp.
- For visually challenged people, tactile warning blocks should be placed 400 mm before the start and finish of each ramp at the entrance to signal the level difference.
- Everywhere there are steps, there should be a 50mm color contrast on the tread edge to aid the elderly and persons with vision impairments even in low light.
- Handrails ought to be present on ramps and steps.

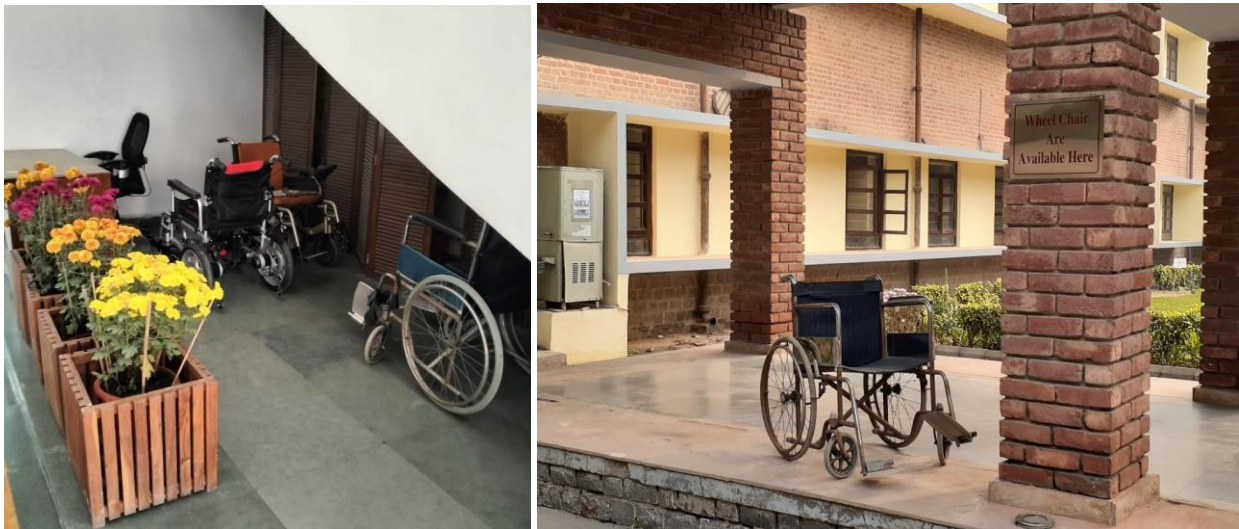
2.2 RECEPTION

- There was no specific reception desk signage visible.
- The enrolment procedures were carried out on-site at the college.
- There were no reception signs, and the reception area is 1100 mm tall.

- Provide guests with a distinct registration/reception desk at the entry, with a clear knee space of 350mm at the counter.

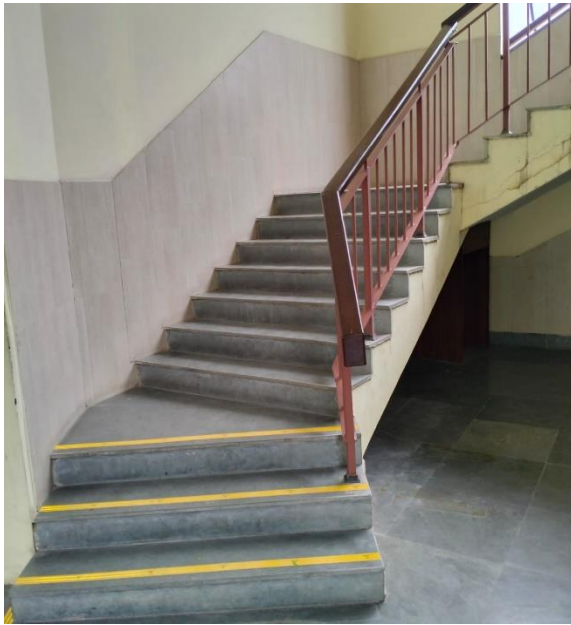
2.3 STAIRCASE

- There are 13 stairs with a landing, each with a riser of 160 mm and a tread of 260 mm that is 1450 mm wide.
- Wall-shaped handrails are present on both sides and extend up the stairs.
- The floor surface is non-slippery and non-reflective, which is a good practise.

- It is ideal to have railings on both sides and at two heights, or 700mm and 900mm, to accommodate adults and children of all sizes.
- Railing in open areas must be insulated for temperature (Hot/ Cold) effects.
- On the landing, the railings ought to remain in place.

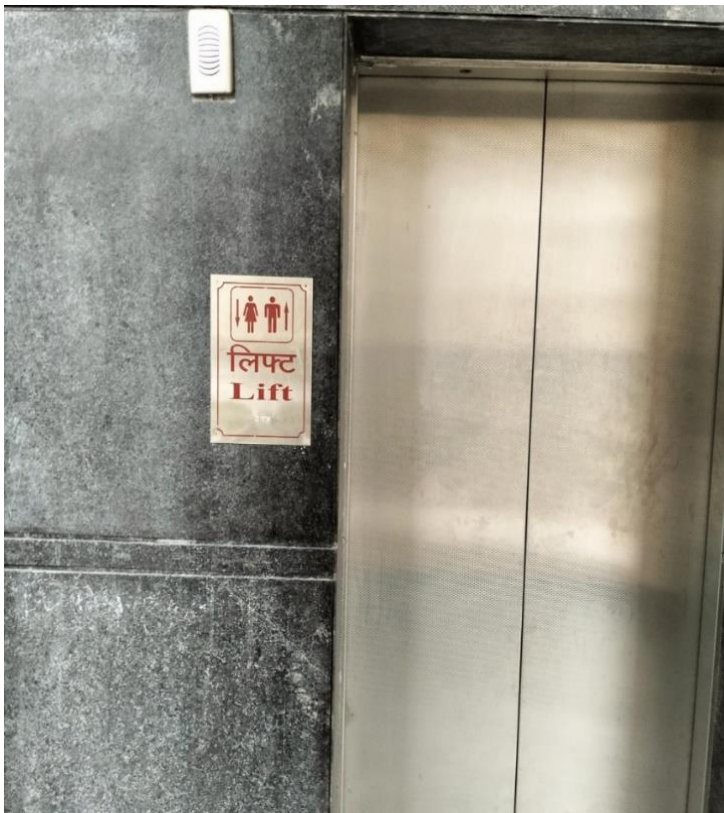
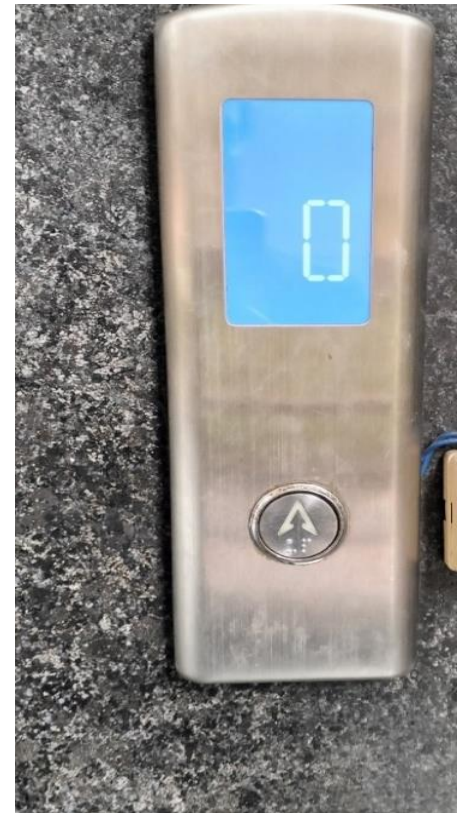
2.4 LIFT/ Elevator

- There is a lift in new building block that is open for faculty members and needy students.
- Buttons in the lift are with braille marking standards considering visually impaired people.
- The lift has audio announcement features in Hindi and English (dual language).
- The lift has help and call functions for any kind of assistance.
- The lift has a proper lighting system installed for better visibility.

- At each entry, there needs to be clear signage pointing in the direction of the elevator.
- For a wheelchair user to independently utilize the lift, there needs to be a rearview mirror on the lift's back wall.

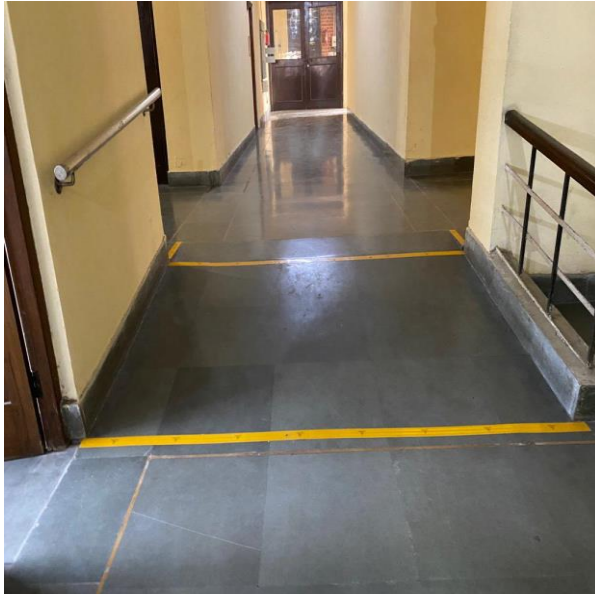
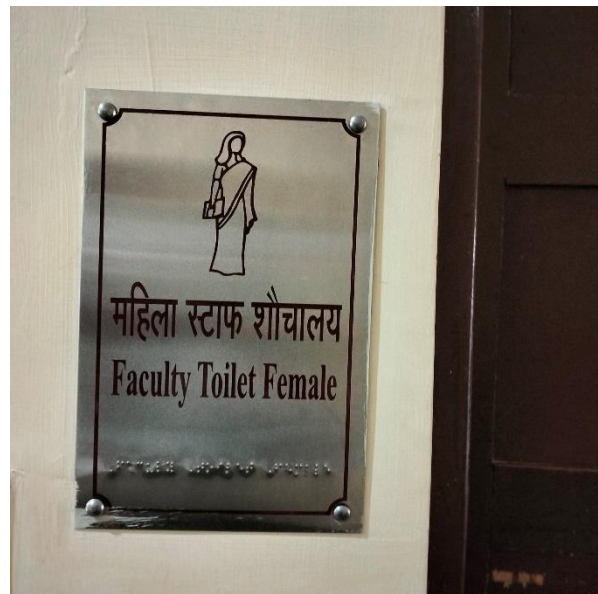
2.5 CORRIDORS AND DOORS

- The hallways are sufficiently wide (2300 mm), and no protruding objects lie in between.
- Displaying vibrant colour contrast.
- The illumination is just ok, in future, please maintain minimum 200 Lumens in corridors.
- Although slightly brilliant and reflective, the surface is not slippery.
- There is appropriate signage at the entrance.
- The signage that is currently displayed is too high and has poor color contrast.

- Doors with a handle height of 1200mm and a clear width of 1300mm.
- Consider adding adequate, evenly distributed illumination to the hallways.
- Give the entrance, walls, ceiling, and floor contrast in colour in future maintenance work.

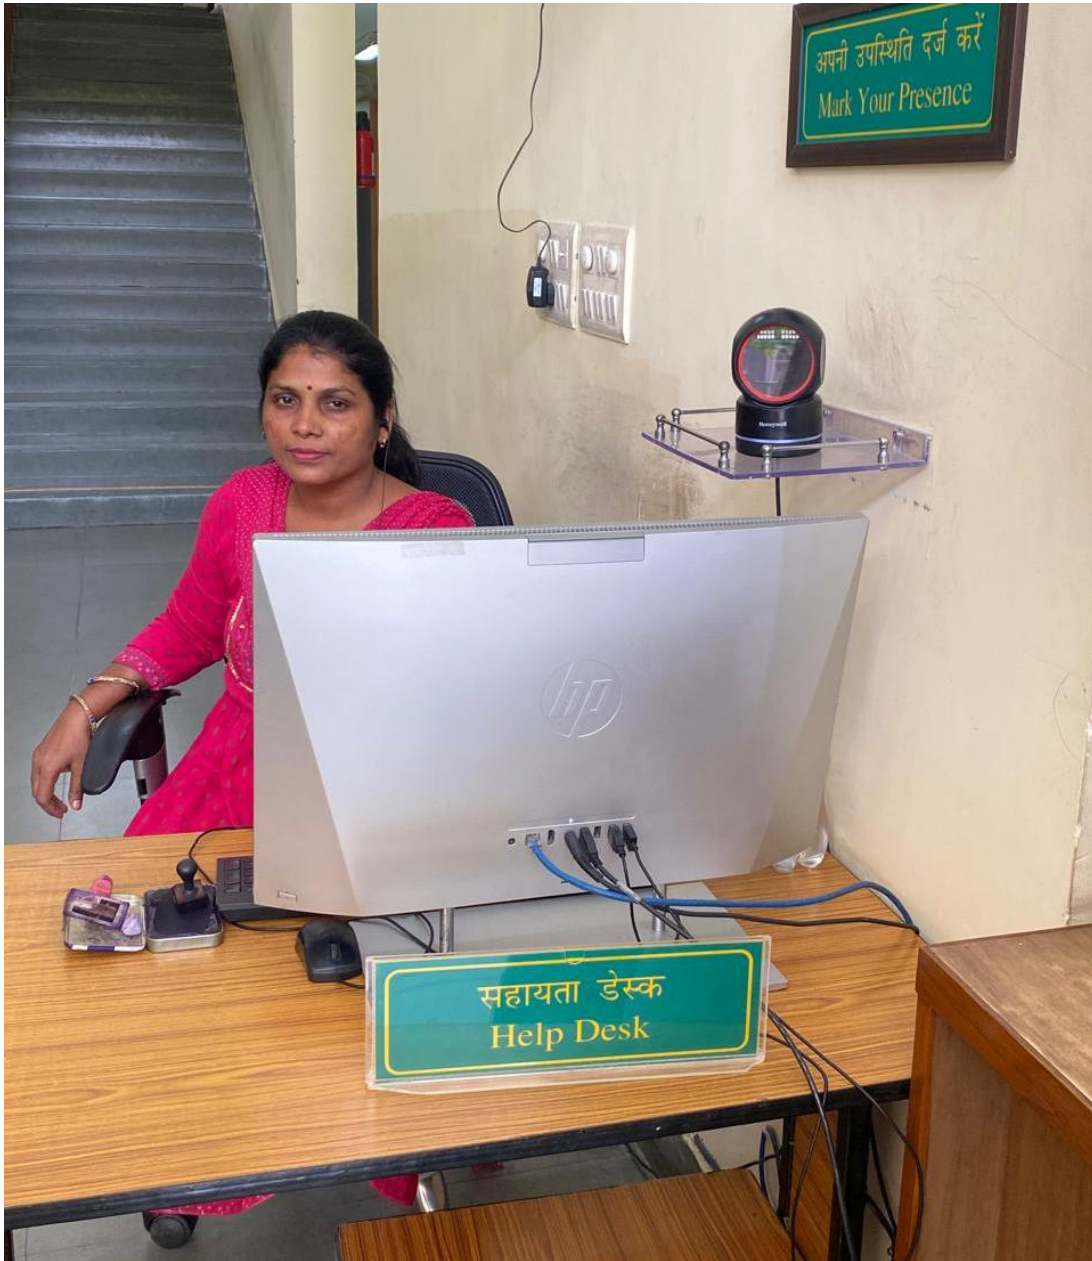
2.7 LIBRARY – HELP CENTER

- Library space is offered in the same building.
- There are two ramps for entry.
- Library building is easy to reach but not that easy to access by visually impaired person, so library staff assisting in person to needy students as per the requirements.

- Ramps to enter into the library, needs to be marked with proper color contrast.
- Regular maintenance of ramps and handrails is suggested by the audit team.
- Signage needs to be visible at a clear height and color contrasted.

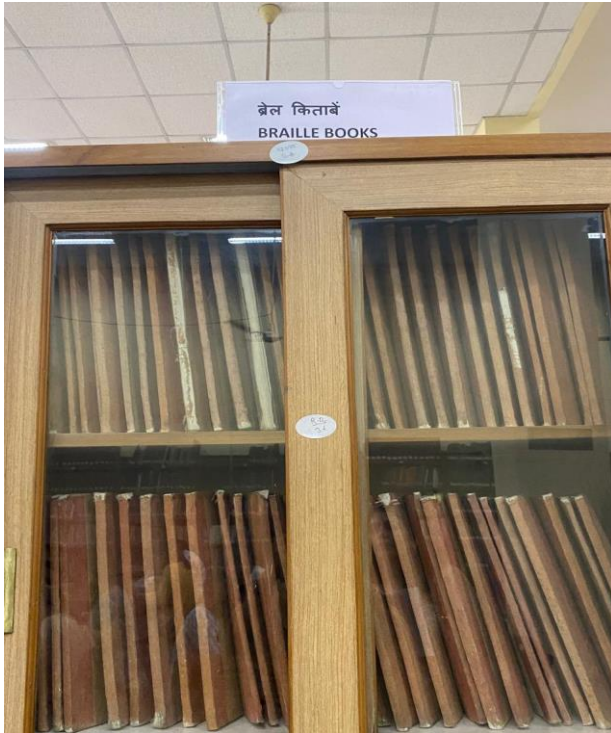
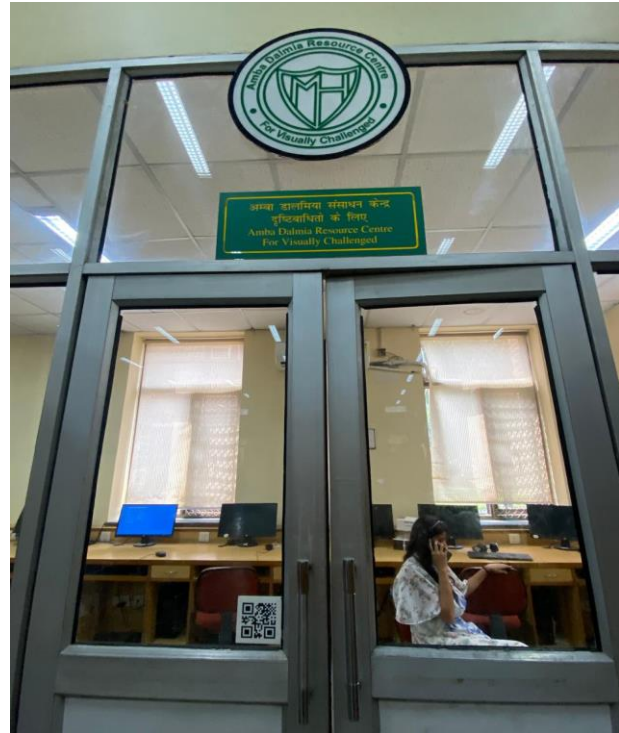
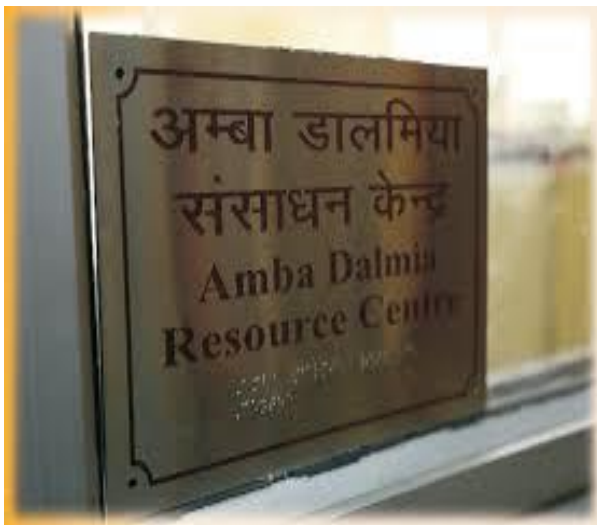
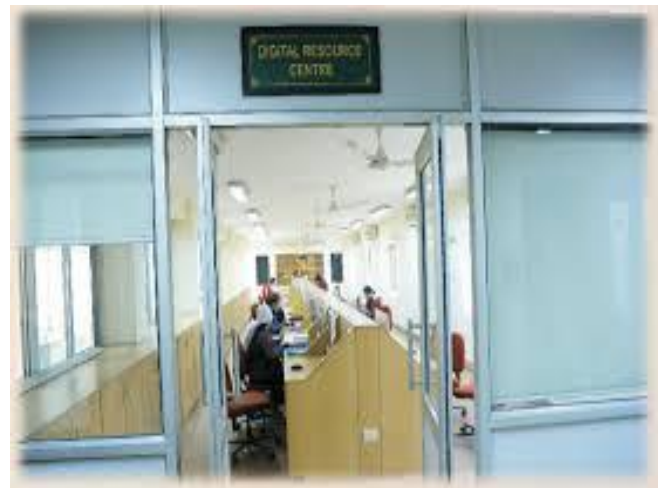
2.8 Amba Dalmia Resource Centre for Visually Challenged

- Amba Dalmia Resource Centre is located in library area.
- There are two ramps for entry.
- Library building is connected with tactile path that is in very good condition and maintained
- Library building is easy to reach but not that easy to access by visually impaired person, so Library staff assisting in person to needy students as per the requirements.

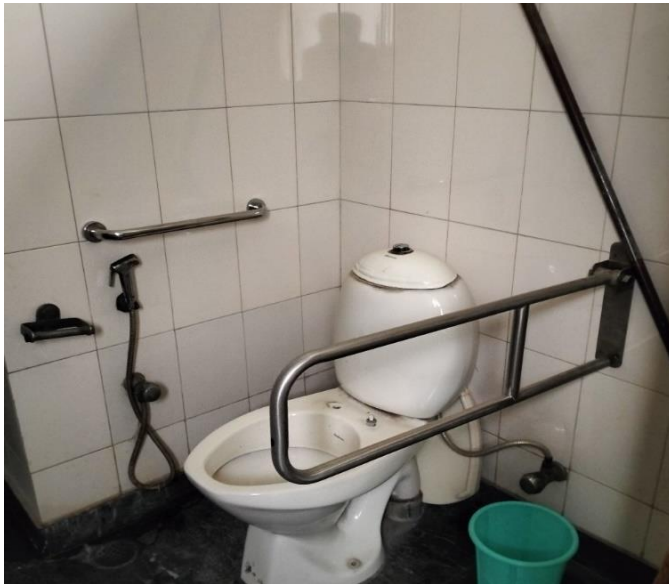
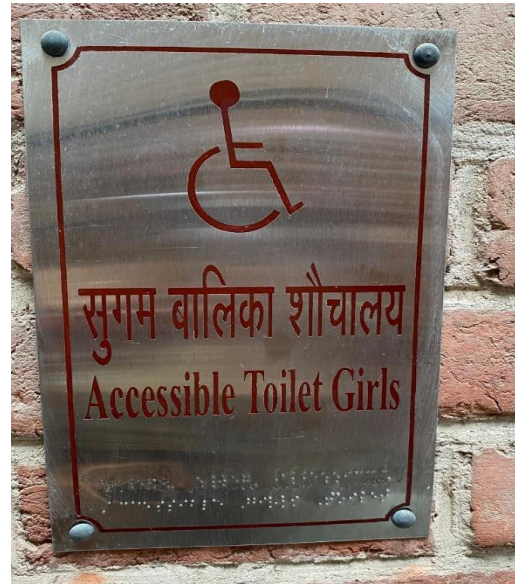
2.10 TOILETS

- The signage is illegible and insufficient.
- The urinal has a 700 mm urinal height and a stepped (100) entrance.
- A washbasin with a 1000mm height but no mirror.
- Western toilet with a 400mm height.
- There are inadequate sanitary conditions and proper toilet maintenance.
- The restroom lacks adequate illumination and colour contrast.

- Install sufficient directional signage pointing to an accessible public restroom.
- Ensure that the toilet unit is routinely maintained and cleaned.
- To prevent accidents due to slipping or skidding, it is advisable to keep your restroom floor dry.

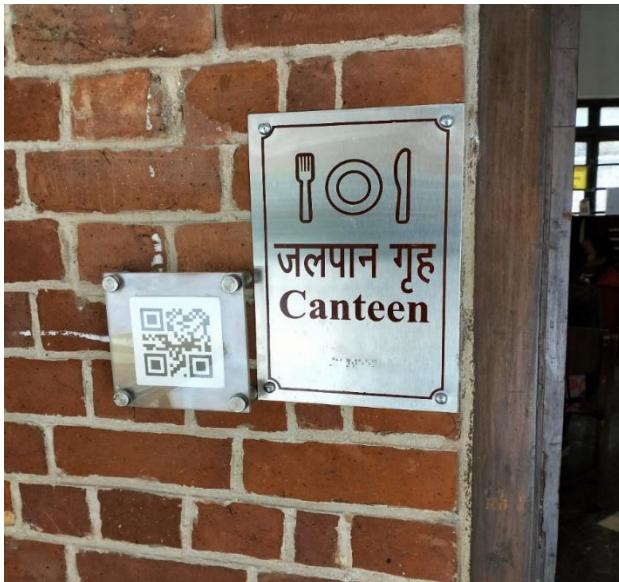
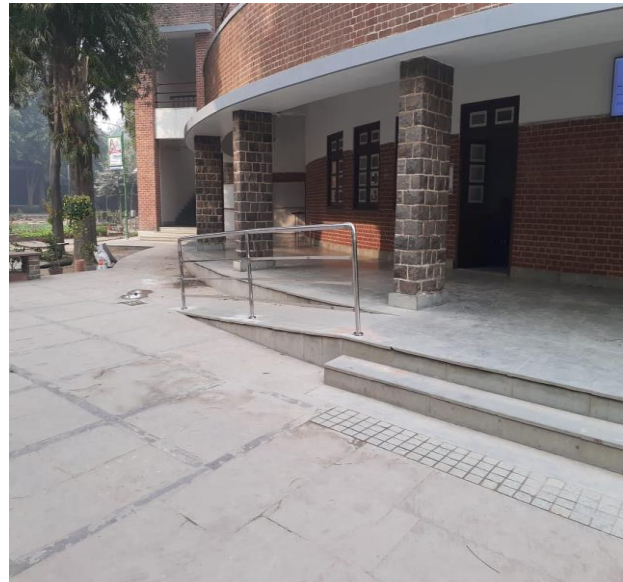
2.12 CAFETERIA

- The college had a main canteen and a few tuck shops on the college premises.
- Both a ramp and steps are used for entry and the main gate has signage with braille.
- The corridor is approximately 3000 mm wide.
- Water is only available at tables and is available at a height of 800mm.

- The access to the canteen shouldn't have any obstacles.
- There should be a wide enough gate so that entering the canteen won't be difficult.
- Wheelchair users need a counter with enough room for their knees.

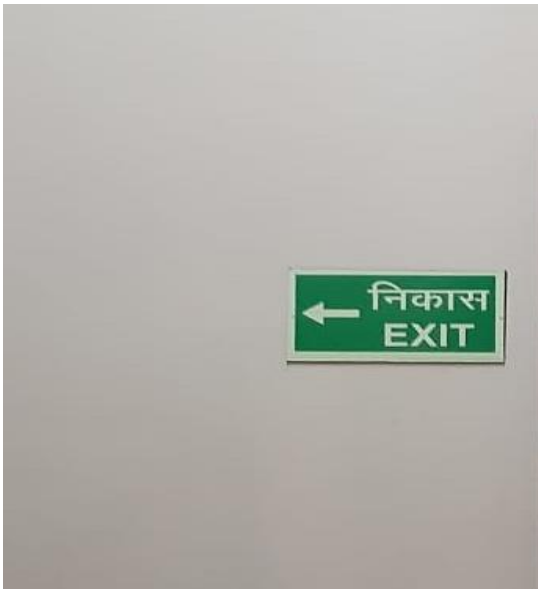
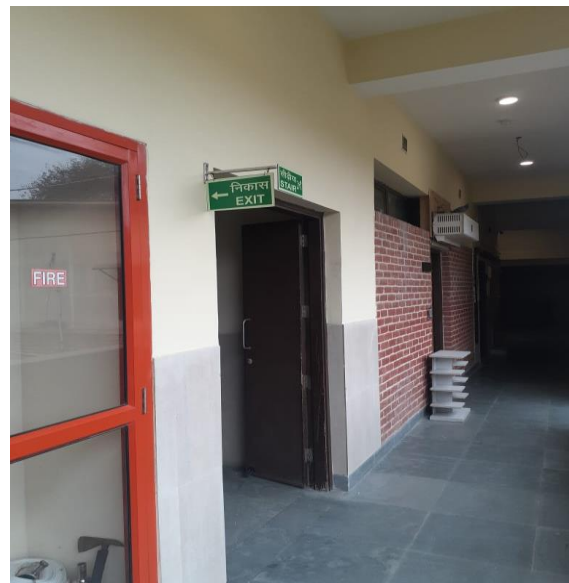
2.13 EMERGENCY EVACUATION

- There are many emergencies signage for any bodies.
- Few more signage are required according to the emergency evacuation plan.

- At key positions on each floor or level, emergency exits should have both auditory (hooter type) and visual (flashing bulb) alarms.
- Conduct recurring training sessions for personnel on handling emergencies and promoting disability equality.
